SELF-HEALING CONCRETE MIX-DESIGN BASED ON ENGINEERED CEMENTATIONS COMPOSITES PRINCIPLES

K. Shobana, R. Aarthi, P. Madhan, L. N. Aparna
Department of Civil Engineering
Nehru Institute of Technology
shobanarythm@gmail.com - Corresponding Author

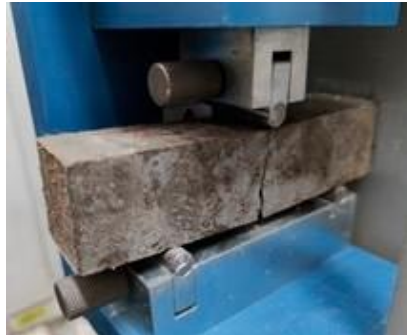
Figure 6. Mechanical parameters of the mixtures: (a) 3PB test; (b) compressive strength.

Tests regarding the mechanical properties of the material were performed at 28 days, on 40 × 40 × 160 mm samples to obtain flexural and 1600 mm² samples for compressive strength (Figure 6).

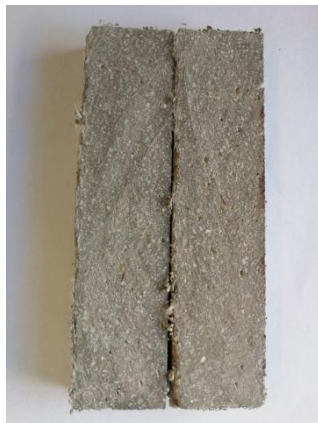
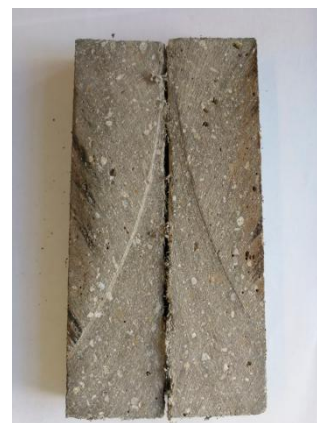
Figure 7. 3PB section samples for self-healing preparation: (a) T1; (b) T2.

Three specimens were cut in halves and tested for the evaluation of the microcracks (Figure 7). To evaluate the self-healing capacity of the micro-concrete, the specimens after being tested were microscopically analyzed using a LEICA DMC 290 Microscope. The specimens after being tested [15] at 28 days were microscopically evaluated with measuring the microcracks and were subjected to 28 cycles of wet/dry. The wet/dry cycles were 12 h immersed in water and 12 h in air in laboratory conditions ($(20 \pm 2) ^\circ\text{C}$ and $(50 \pm 3)\%$ RH) and after 28 days were microscopically reanalyzed. The microcracks width was measured before and after the conditioning of the specimens in order to evaluate the self-healing capacity.

The self-healing capacity of the samples was also tested by subjecting the samples presented in Figure 7 to a 3PB test in order to generate cracks on the surface of the samples, after which the samples were microscopically analyzed. After that, the samples were subjected to 28 wet/dry cycles (12 h immersed in water/12 h in air) and resubjected to microscopical analysis (Figures 9 and 10). Consequently, for all the samples, at each stage, the mean width of the microcracks (w_{med}) was measured as a parameter of the self-healing capacity (Table 4).
